## ABCOV® Treats Natural Occurring Asbestos In Silt, Dirt, and Rock Pilot Plant Test Results

### Overview:

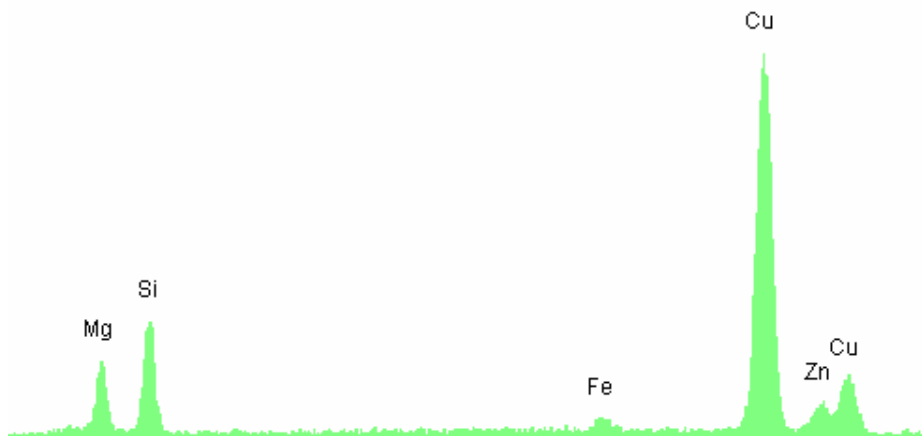
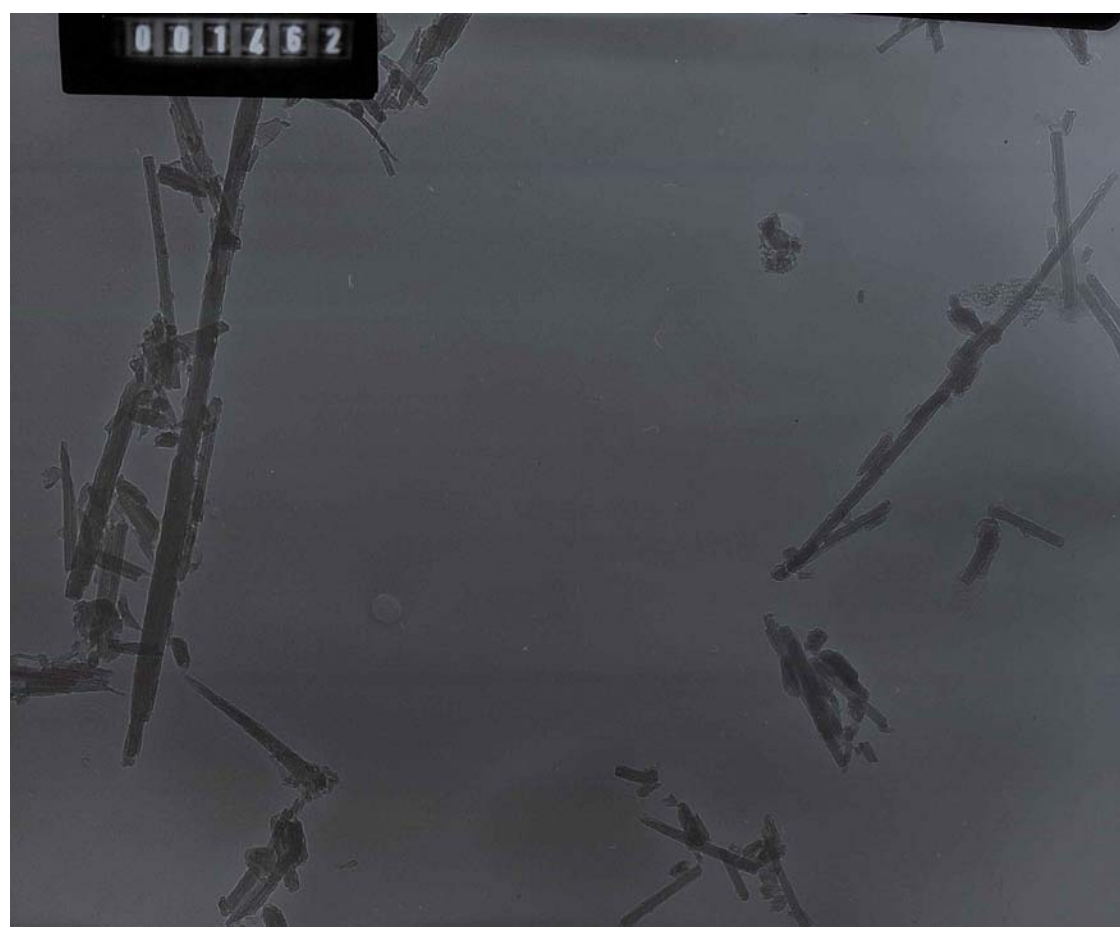
**Sample 1**

**Attachment C: TEM Photo of Material Before ABCOV® Treatment**

**Chrysotile Spectrum and Field of View Image**

TEM Photos of the combined silt, rock and dirt before, exhibited in Attachment C, and after ABCOV® treatment exhibited in Attachment D.

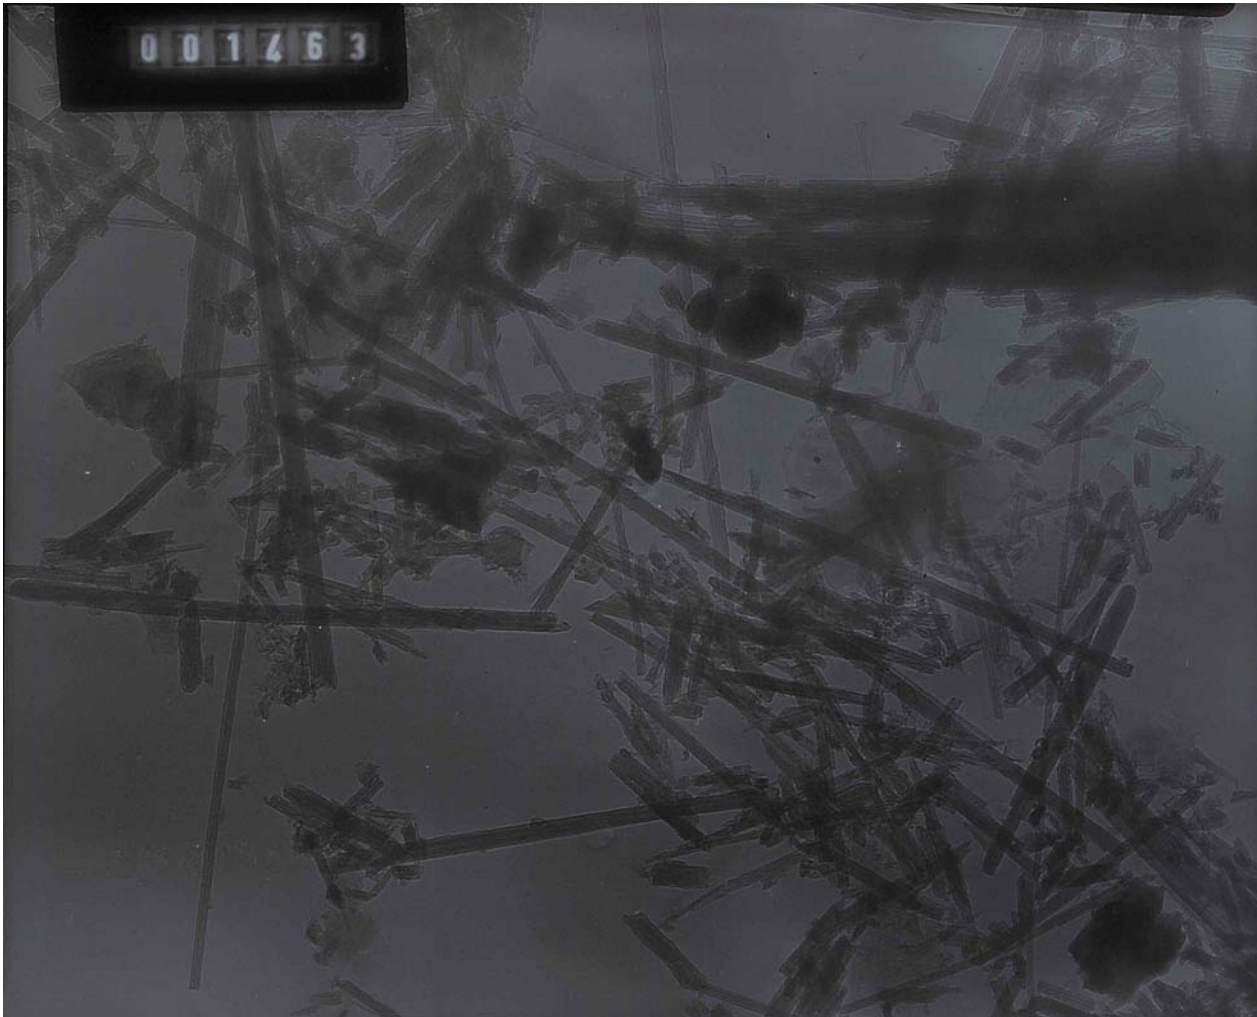
**Sample 1**

**Attachment C: TEM Photo of Material Before ABCOV® Treatment**

**Field of View Image**

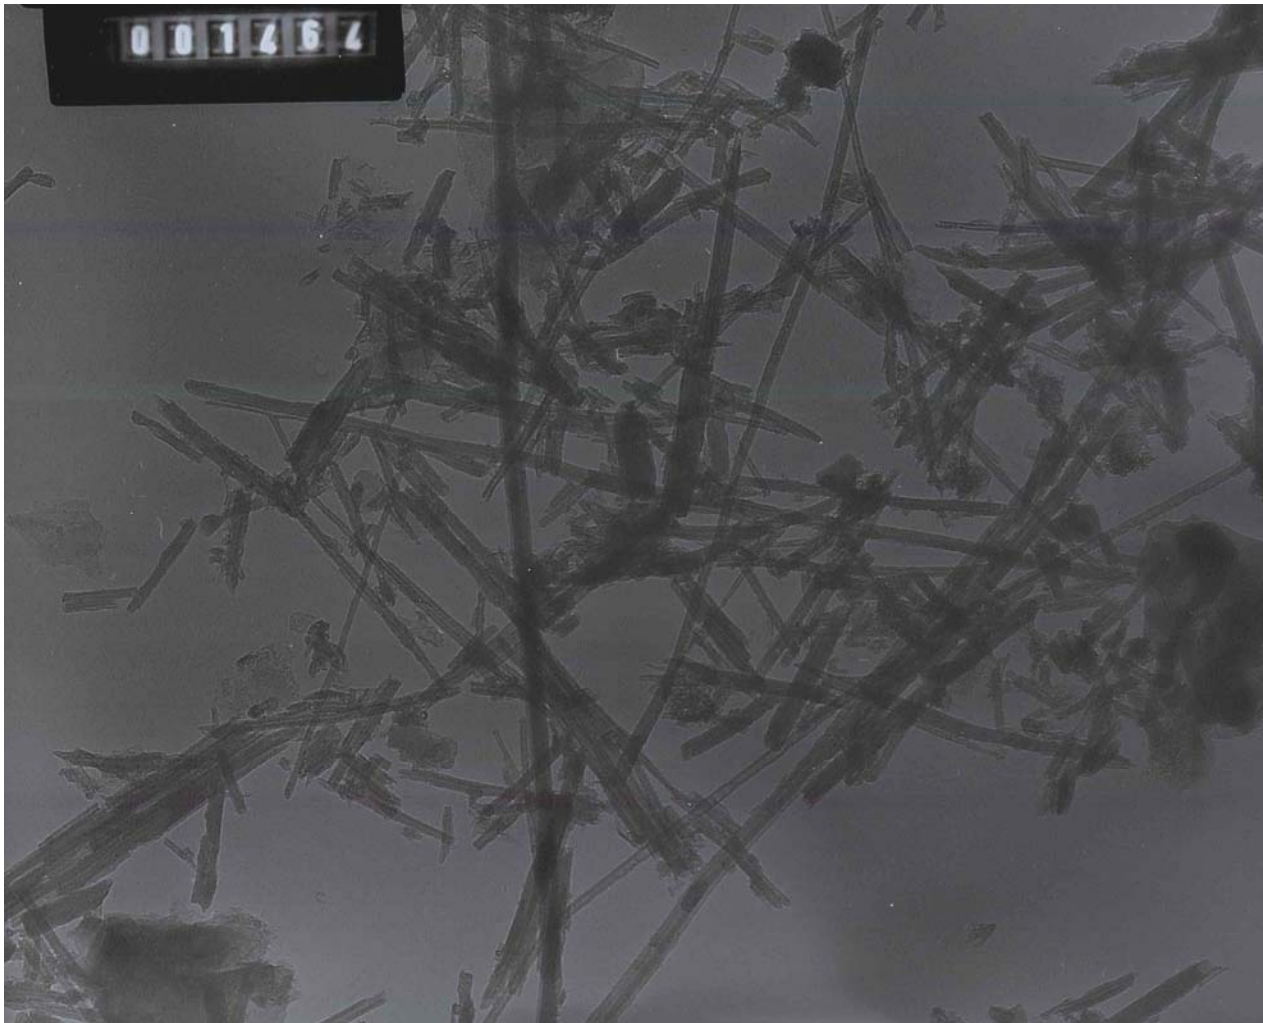
**Sample 1**

**Attachment C: TEM Photo of Material Before ABCOV® Treatment**

**Field of View Image**

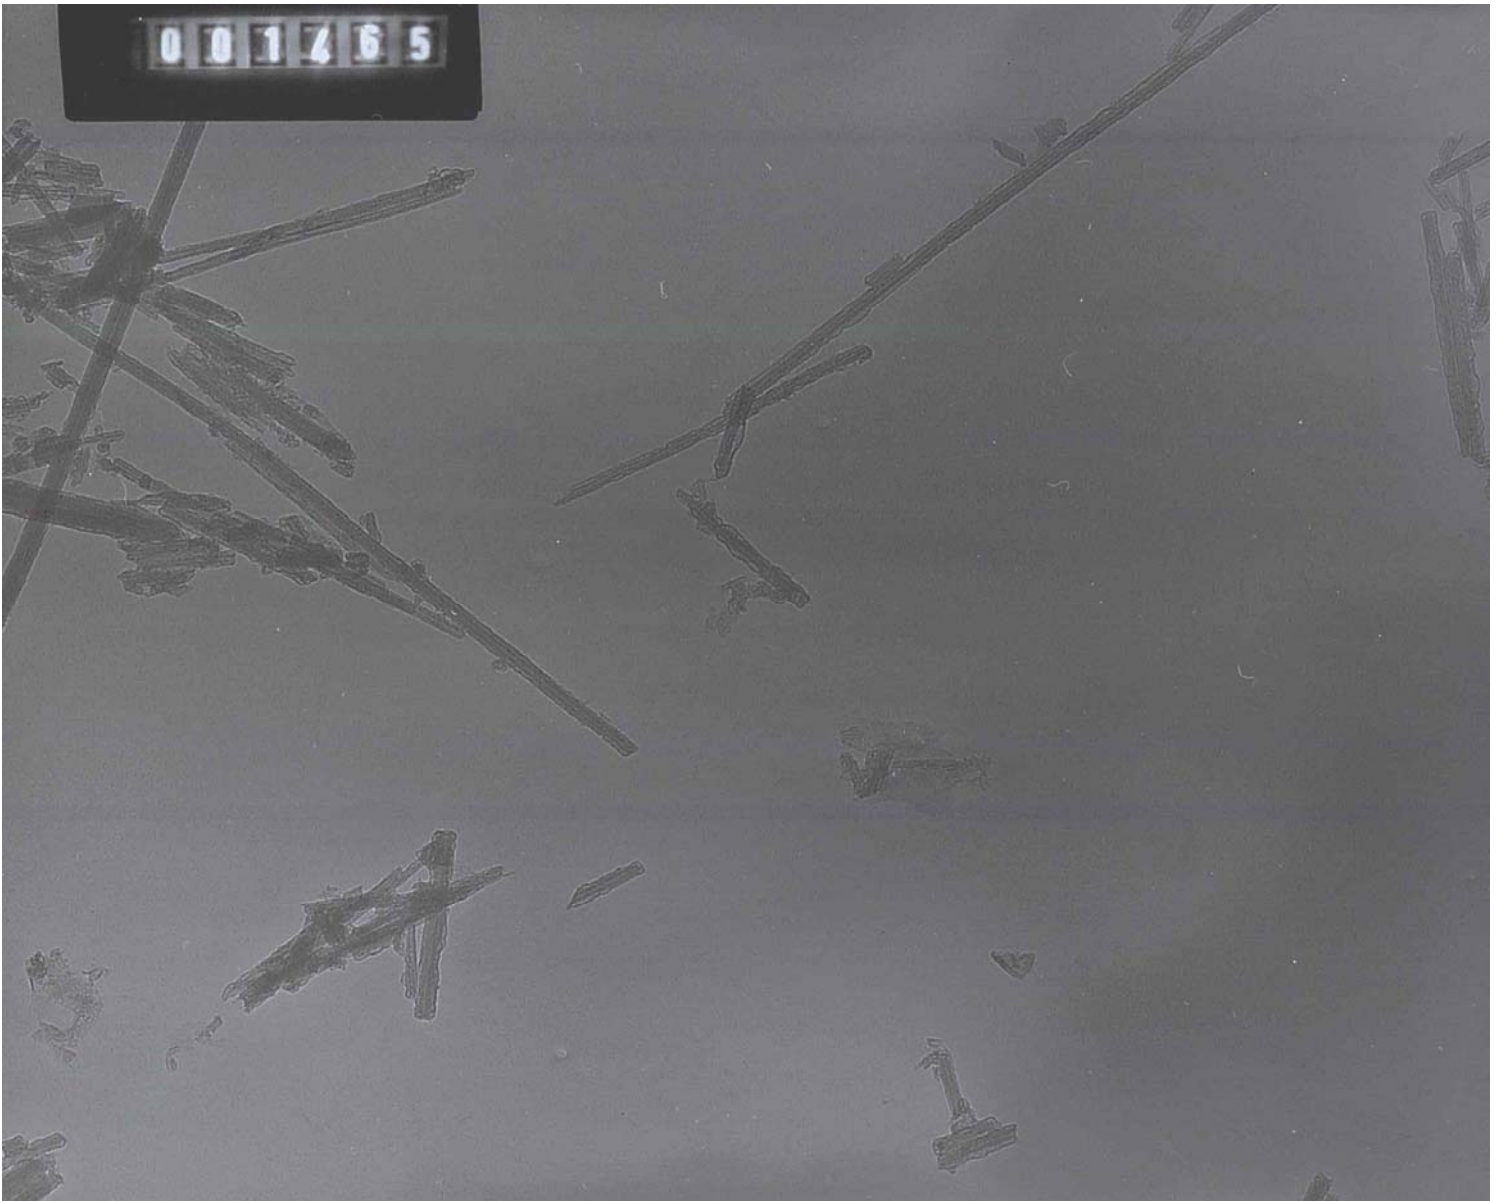
**Sample 1**

**Attachment C: TEM Photo of Material Before ABCOV® Treatment**

**Field of View Image**

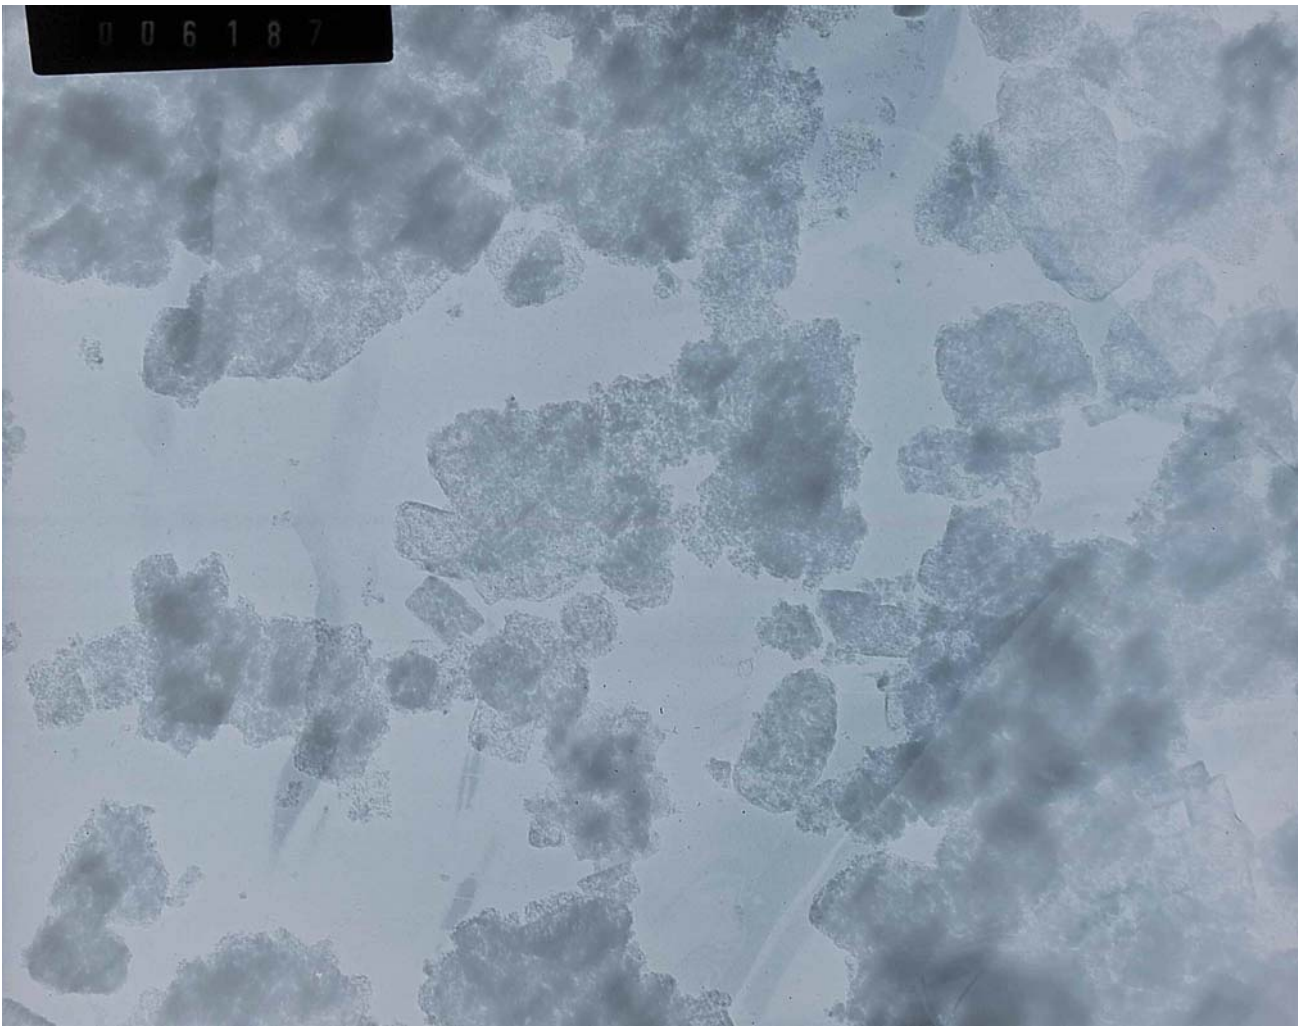
**Sample 2**

**Attachment D: TEM Photo of Material After ABCOV® Treatment**

**Field of View Image – No Asbestos Detected**
